BELOW-THE-HOOK SUCCESS STORY

...EMERGENCY SCRAP TONG REPAIR

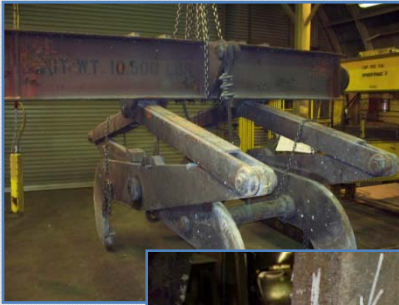
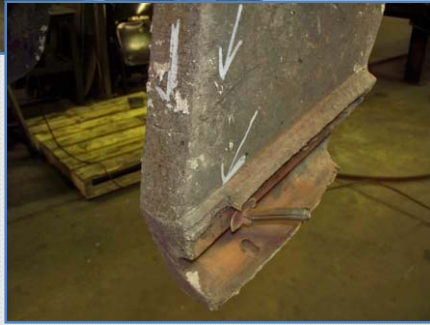
The operations at a major US aluminum mill were severely affected by the failure of a mechanical tong used for charging furnaces with scrap.

The OEM design had a two-piece, welded block for retaining the tong points. This construction is inexpensive to manufacture, but due to the application, also susceptible to weld cracking along the split line.

After a thorough inspection, cracking at the remaining tong point blocks was discovered...all four legs would need to be repaired. A one-piece block and replaceable tong point were quickly designed and fabricated.

Alloy steel for both blocks and points was used for better performance in the harsh operating environment.

Precise measurements before and after the modifications ensured the lift functioned to original design specifications.
