BELOW-THE-HOOK SUCCESS STORY

...ROLL LIFTING BEAM

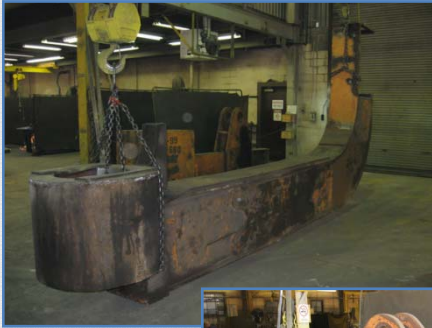
The used lifter had some structural damage and no markings for rated capacity. As the lifter was very large, plant personnel torched the unit into two pieces for ease of transport to Bradley Lifting.

Bradley Lifting performed a detailed stress analysis on the lifter. To achieve a 35 ton rated capacity, several sections in the main, fabricated body required reinforcement. Finite element analysis also determined the roll neck sleeve required strengthening by an external ring.

Bradley engineers recommended another modification: create a permanent two-piece design so the counterweight and main body could be assembled in the field...saving well over \$15,000 in transportation costs.
